Navajo Abandoned Uranium Mine

Site Screen Report

NA-0238 AUM Site

Weston Solutions, Inc.

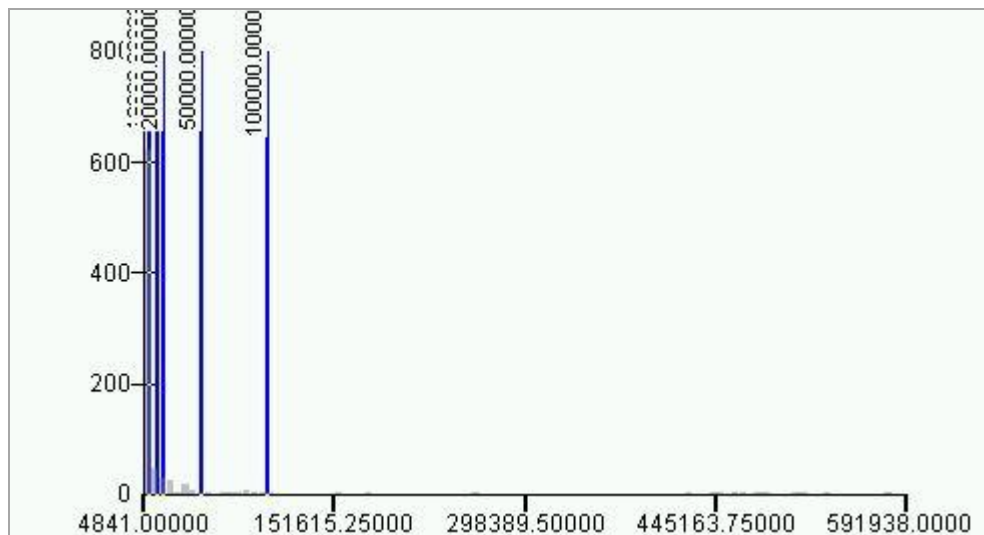
Distribution Chart and Statistics:

The following chart and statistics were generated by ESRI ArcGIS 9.3.1, and show the general distribution of the site gamma radiation measurements. The horizontal X axis represents the gamma radiation reading levels in cpm (lowest levels to the left). The vertical Y axis represents the frequency of each gamma radiation level.

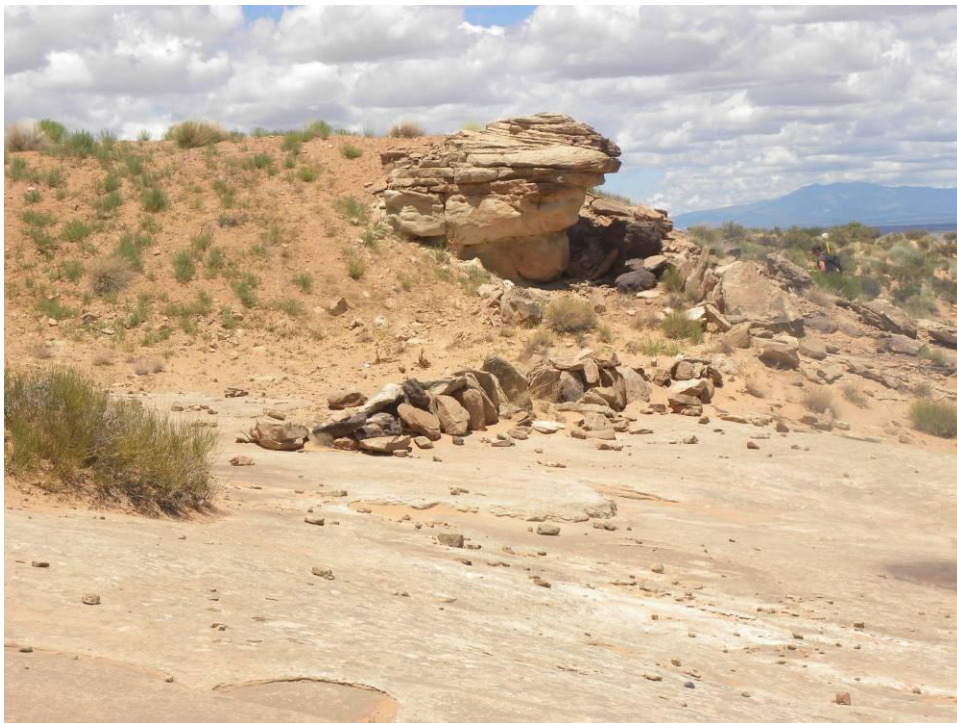
Photo 2. NA-0238 site, rock wall and reclamation cap

Reclamation cap of fine, red clay with gamma radiation hot spot; yellow rock with elevated radiation levels onsite; rock wall consisting of dark rocks and elevated gamma radiation readings

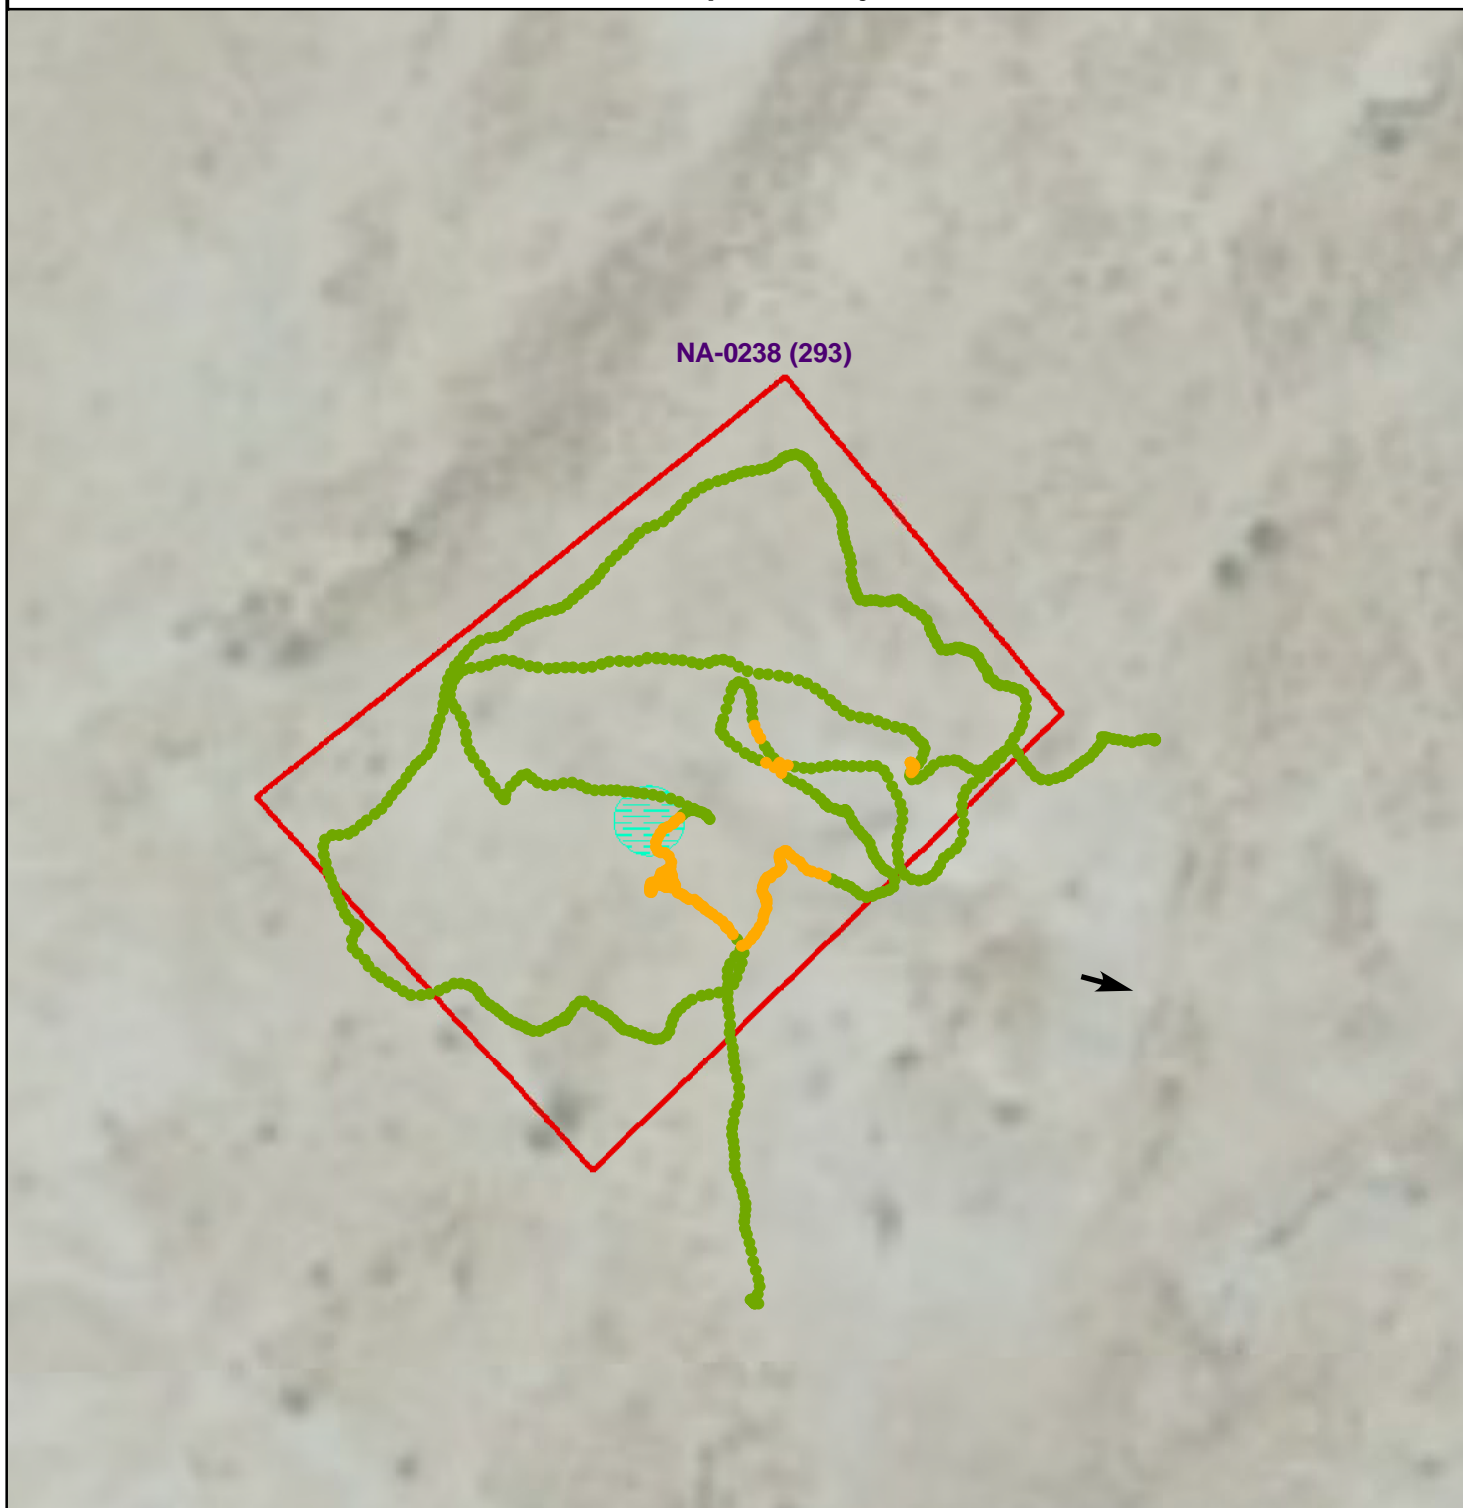
**Figure 1 - Gamma Radiation Measurements, Above Two Times Background
NA-0238 (293)
Red Mesa Chapter, Navajo Nation**

A total of 840 gamma radiation measurements were collected from the mine site, ranging from 4,841 cpm to 591,938 cpm. Measurements collected in the vicinity of the rockwall were found at levels up to approximately 25,000 cpm, and at an isolated hotspot at levels over 550,000 cpm. The measurements are represented in Figures 1 and 2.

Gamma survey conducted 06/2010
Measured as counts per minute (cpm)

Average background = 5,643 cpm

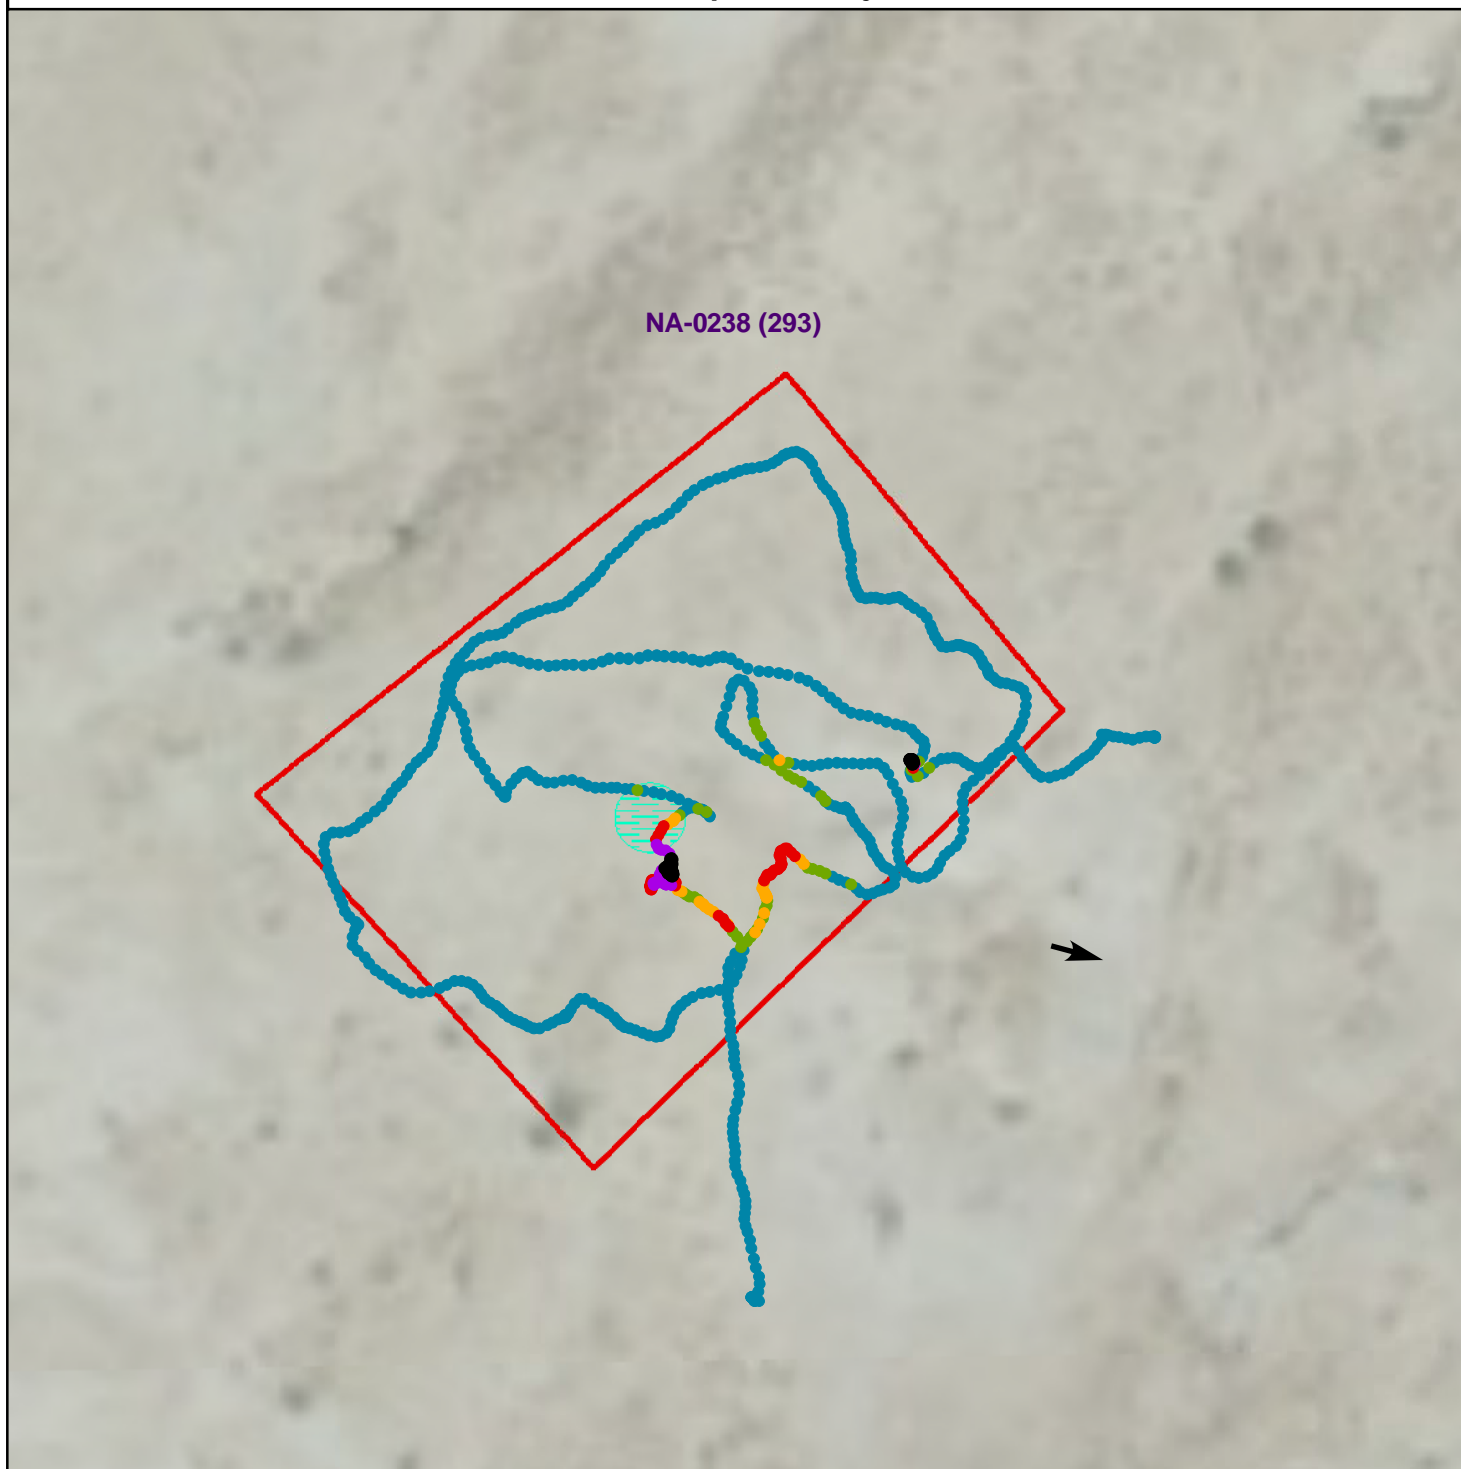
Figure 2 - Gamma Radiation Measurements
NA-0238 (293)
Red Mesa Chapter, Navajo Nation

Gamma survey conducted 06/2010
 Measured as counts per minute (cpm)

Average background 5,643 cpm
